**Flood Control Project Maintenance  
Levee Inspections**

**Fall 2018 Levee Maintenance Deficiency Summary Report**

**Sacramento River Basin**

**Sacramento Maintenance Yard Willow Slough Bypass**

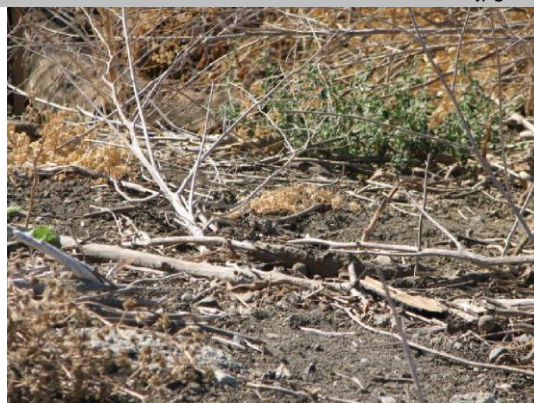
Photo 2 of 3 : UCIP\_FA\_2018\_44903\_22881.jpg

Waterside view- general view

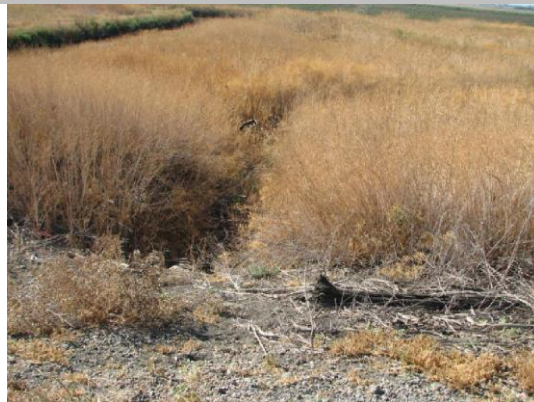
Photo 3 of 3 : UCIP\_FA\_2018\_44903\_22880.jpg

Waterside overview. Notice waterway.

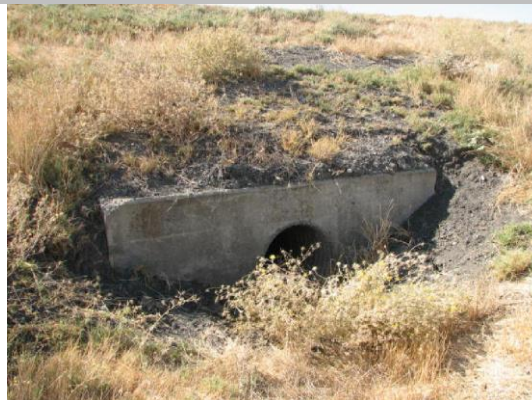
Photo 1 of 3 : UCIP\_FA\_2018\_44907\_22894.jpg

Comment Code					
Inspector Comment					
FS_ID:44907 DS_ID:17608 EP_NO: 10313 Repair Type: No Action Needed Crossing Status: Found UCIP Comments: 04/12/2017 LS - dump has it plugged, WS - ditch need to be established debris higher than water, inspected by JK, RF. (DWR Sacramento Yard - C. Lund) 09/19/2012 Pipe sits on concrete saddle on WS. (DWR UCIP - P. Amatya) FIELD_STRUCT_DESC: 24-inch corrugated metal drainage pipe through the levee, 13.5 feet below the crown. Flap gate is located on the waterside (WS) end. (24-inch pipe [HLM 0.79] authorized under Automatic Board Order (ABO) issued as Permit No. 10313, 1974 - Lear). [Additional Reference(s): DWR Levee Log, 1990. USACE Sacramento O&M Manual Unit 120, Willow Slough Channel Relocation and Levee Construction, February 1947, Drawing No. 50-4-2281 Sheet 2, 4 (Station 232+43)] FS Date: 5/5/2015 8:06:14 AM

Landside view- pipe and headwall

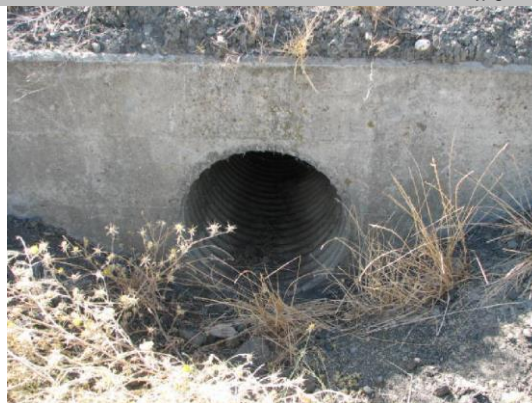
Photo 2 of 3 : UCIP\_FA\_2018\_44907\_22893.jpg

Landside view- pipe and headwall closer view

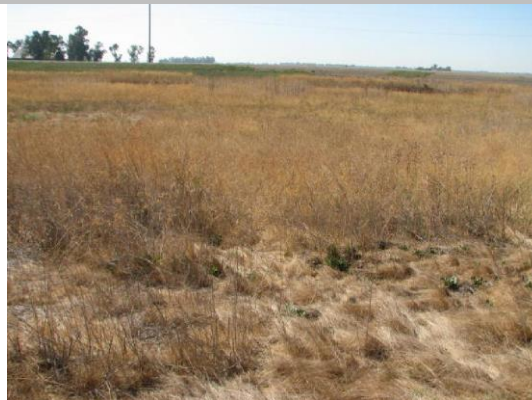
Photo 3 of 3 : UCIP\_FA\_2018\_44907\_22892.jpg

Comment Code						
Inspector Comment						
FS_ID:44907 DS_ID:17608 EP_NO: 10313 Repair Type: No Action Needed Crossing Status: Found UCIP Comments: 04/12/2017 LS - dump has it plugged, WS - ditch need to be established debris higher than water, inspected by JK, RF. (DWR Sacramento Yard - C. Lund) 09/19/2012 Pipe sits on concrete saddle on WS. (DWR UCIP - P. Amatya) FIELD_STRUCT_DESC: 24-inch corrugated metal drainage pipe through the levee, 13.5 feet below the crown. Flap gate is located on the waterside (WS) end. (24-inch pipe [HLM 0.79] authorized under Automatic Board Order (ABO) issued as Permit No. 10313, 1974 - Lear). [Additional Reference(s): DWR Levee Log, 1990. USACE Sacramento O&M Manual Unit 120, Willow Slough Channel Relocation and Levee Construction, February 1947, Drawing No. 50-4-2281 Sheet 2, 4 (Station 232+43)] FS Date: 5/5/2015 8:06:14 AM

Waterside view

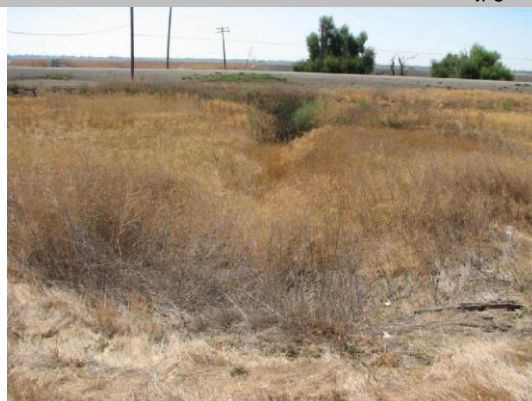
Photo 3 of 3 : UCIP\_FA\_2018\_44929\_22931.jpg

Waterside overview

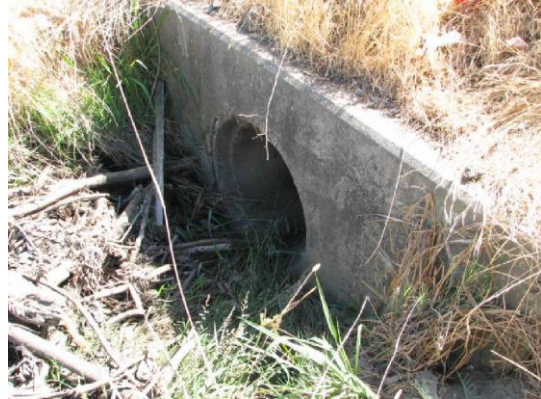
Photo 1 of 3 : UCIP\_FA\_2018\_44937\_22951.jpg

Landside view- concrete pipe and headwall.

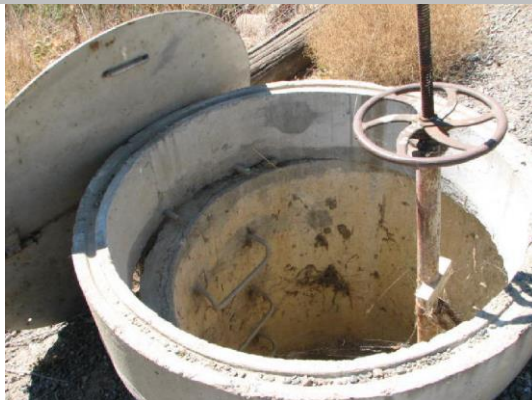
Photo 3 of 3 : UCIP\_FA\_2018\_44937\_22948.jpg

Waterside view- concrete manhole.

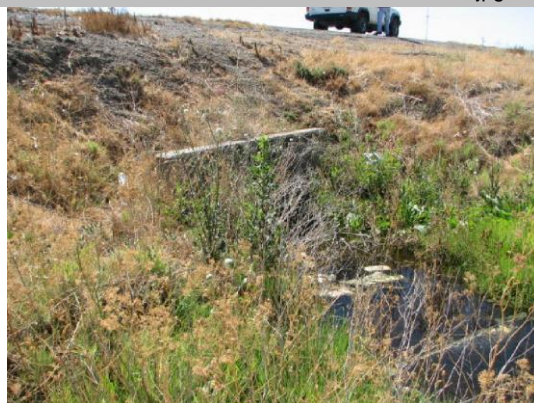
Photo 1 of 3 : UCIP\_FA\_2018\_44942\_22962.jpg

Landside view- inlet structure

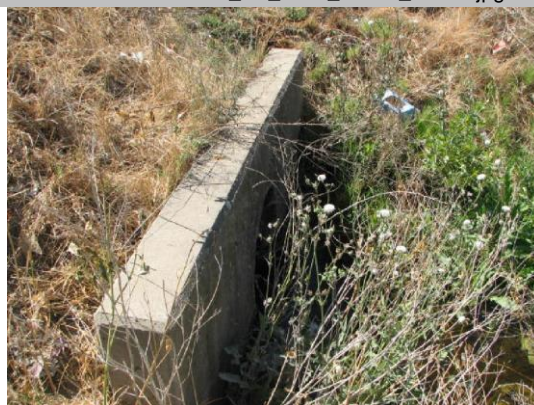
Photo 2 of 3 : UCIP\_FA\_2018\_44942\_22961.jpg

Landside view- concrete headwall

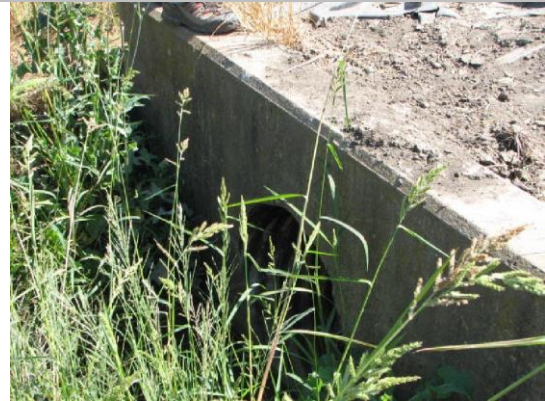
Photo 3 of 3 : UCIP\_FA\_2018\_44943\_22969.jpg

Landside view- pipe and concrete headwall.

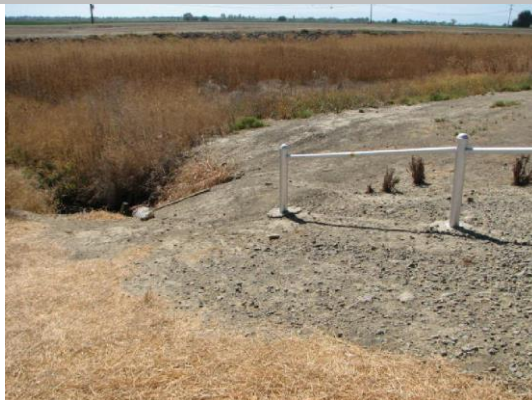
Photo 1 of 3 : UCIP\_FA\_2018\_44947\_22984.jpg

Waterside view- overview

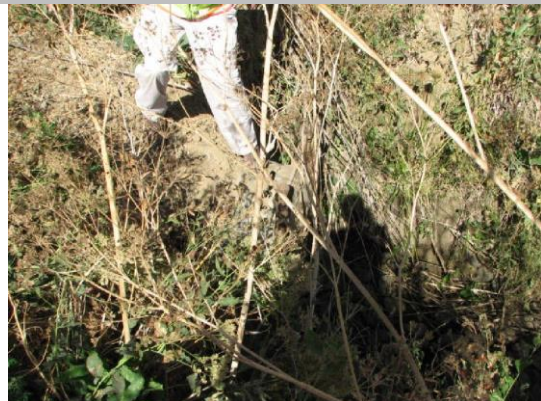
Photo 1 of 3 : UCIP\_FA\_2018\_45286\_22464.jpg

Comment Code						
Inspector Comment						
FS_ID:45286 DS_ID:534 EP_NO: 10327 Repair Type: No Action Needed Crossing Status: Found UCIP Comments: 04/12/2017 WS & LS - good/clear, inspected by JK, RF. (DWR Sacramento Yard - C. Lund) 05/24/2013 Flap gate repaired. (DWR Sacramento Yard - C. Lund) 09/20/2012 Flap gate is not properly closing. (DWR UCIP - P. Amatya) FIELD_STRUCT_DESC: 24-inch corrugated drainage pipe through the levee, 17.5 feet below the crown. Flap gate is located on the waterside (WS) slope. (24-inch pipe [HLM 0.78] authorized under Automatic Board Order (ABO) issued as Permit No. 10327 - Heidrick). [Additional Reference(s): DWR Levee Log, 1990. USACE Sacramento O&M Manual Unit 120, Willow Slough Channel Relocation and Levee Construction, February 1947, Drawing No. 50-4-2281 Sheet 1 (Station 47+00)] FS Date: 5/14/2015 1:36:52 PM

Waterside view- concrete headwall and CM pipe

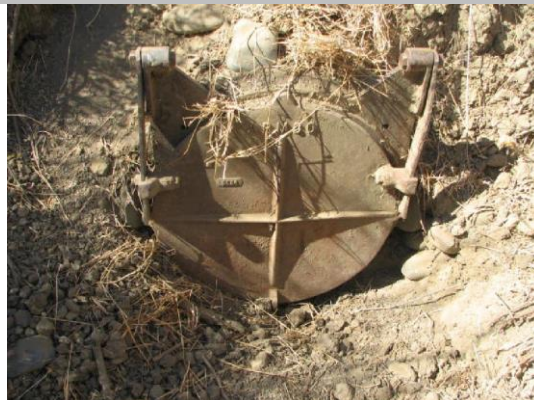
Photo 1 of 3 : UCIP\_FA\_2018\_13725\_22470.jpg

Waterside view- flap gate and CM pipe

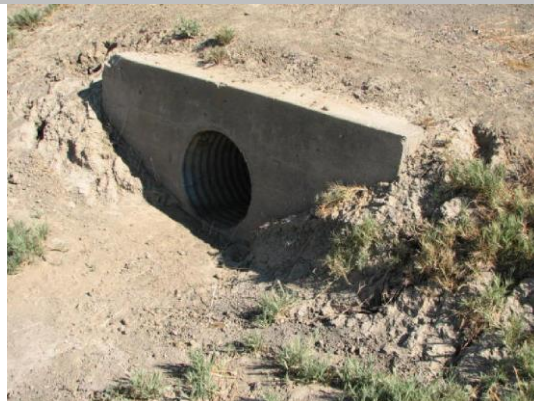
Photo 2 of 3 : UCIP\_FA\_2018\_13725\_22469.jpg

Landside view- concrete headwall and pipe

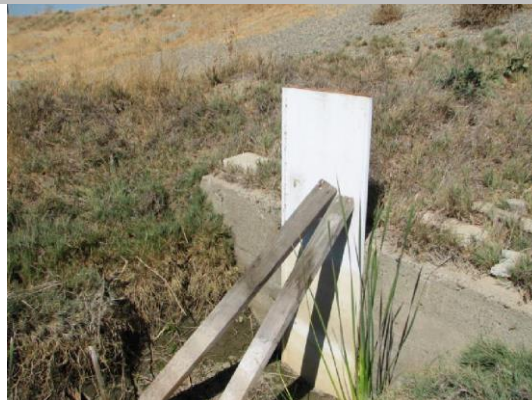
Photo 2 of 3 : UCIP\_FA\_2018\_45291\_22478.jpg

Landside view- concrete headwall

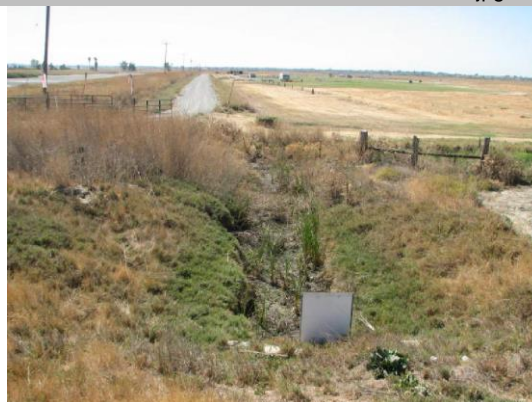
Photo 3 of 3 : UCIP\_FA\_2018\_45291\_22477.jpg

Landside view- open ditch.

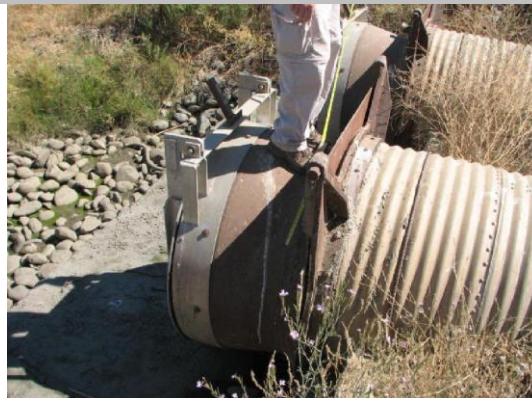
Photo 3 of 3 : UCIP\_FA\_2018\_45294\_22792.jpg

Comment Code						
Inspector Comment						
FS_ID:45294 DS_ID:541 EP_NO: 10335 Repair Type: No Action Needed Crossing Status: Found UCIP Comments: 09/20/2012 Landside view photos are missing. Daylight pipe is a steel pipe. The pipe through the levee may be a CMP. (DWR UCIP - P. Amatya) FIELD_STRUCT_DESC: 1 of 2. 42-inch corrugated metal drainage pipe through the levee, 12 feet below the crown. Flap gate located on the waterside (WS) end. 42-inch pipe sleeved through a 48-inch corrugated metal pipe (CMP). (two 48-inch pipes [HLM 3.54] authorized under Automatic Board Order (ABO) issued as Permit No. 10335, 1974 - Snyder). [Additional Reference(s): DWR Levee Log, 1990. USACE Sacramento O&M Manual Unit 120, Willow Slough Channel Relocation and Levee Construction, February 1947, (Station 192+80)] FS Date: 5/14/2015 1:41:55 PM

Waterside view- 42-inch steel pipe and flap gate.

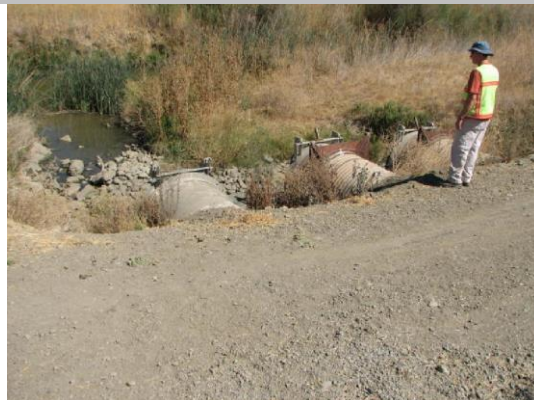
Photo 1 of 3 : UCIP\_FA\_2018\_45295\_22794.jpg

Waterside overview- far right 42-inch pipe.

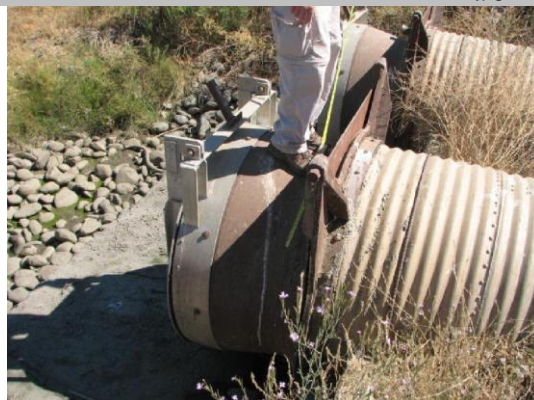
Photo 2 of 3 : UCIP\_FA\_2018\_45295\_22793.jpg

Waterside view- 42-inch steel pipe and flap gate (right).

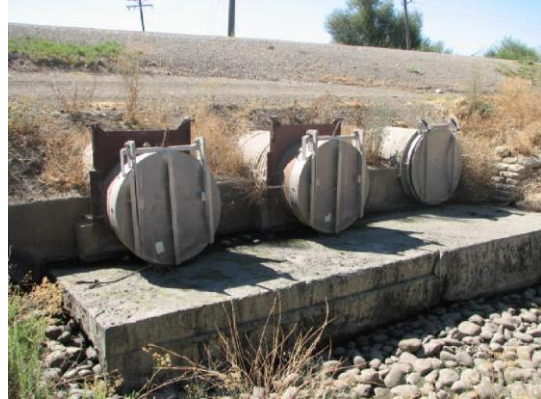
Photo 3 of 3 : UCIP\_FA\_2018\_45295\_22796.jpg

Waterside overview- outlet structure.

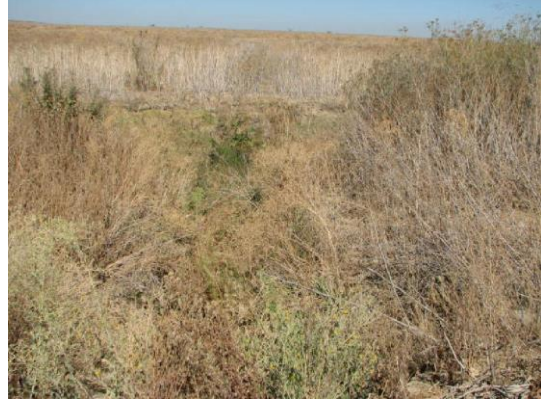
Photo 2 of 3 : UCIP\_FA\_2018\_45298\_22804.jpg

Landside overview

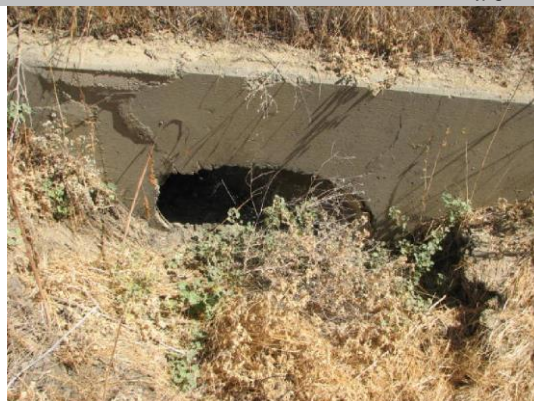
Photo 2 of 3 : UCIP\_FA\_2018\_45285\_22811.jpg

Landside view- pipe and headwall.

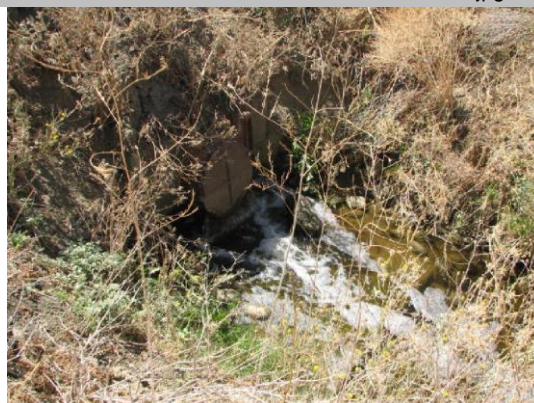
Photo 3 of 3 : UCIP\_FA\_2018\_45301\_22846.jpg

Comment Code						
Inspector Comment						
FS_ID:45301 DS_ID:548 EP_NO: 10321 Repair Type: No Action Needed Crossing Status: Found UCIP Comments: 04/12/2017 WS - good/clear, inspected by JK, RF. (DWR Sacramento Yard - C. Lund) FIELD_STRUCT_DESC: 24-inch drainage pipe through the levee, 17 feet below the crown. Flap gate is located on the waterside (WS) end. (24-inch pipe [HLM 4.97] authorized under Automatic Board Order (ABO) issued as Permit No. 10321, 1974 - Campbell) [Additional Reference(s): DWR Levee Log, 1990. USACE Sacramento O&M Manual Unit 120, Willow Slough Channel Relocation and Levee Construction, February 1947, Drawing No. 50-4-2281 Sheet 4 (Station 268+57)] FS Date: 5/14/2015 1:44:17 PM

Waterside view- pipe and flap gate. Water was running in the pipe during the survey.

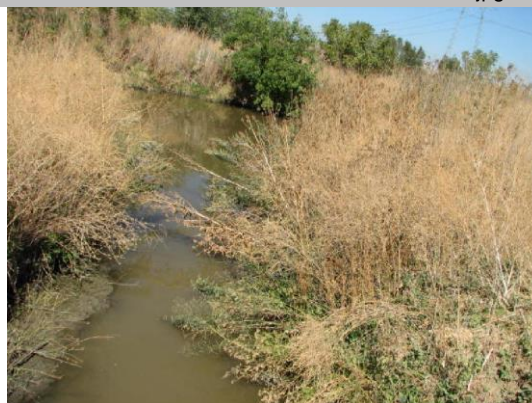
Photo 3 of 3 : UCIP\_FA\_2018\_45302\_22847.jpg

Comment Code						
Inspector Comment						
FS_ID:45302 DS_ID:549 EP_NO: 10322 Repair Type: No Action Needed Crossing Status: Found UCIP Comments: 04/12/2017 WS - submerged in water, inspected by JK, RF. (DWR Sacramento Yard - C. Lund) FIELD_STRUCT_DESC: 24-inch corrugated metal drainage pipe through the levee, 17.5 feet below the crown. Flap gate is located on the waterside (WS) end. Concrete headwall with wing walls is located on WS. (24-inch pipe [HLM 5.32] authorized under Automatic Board Order (ABO) issued as Permit No. 10322, 1974 - Chew). [Additional Reference(s): DWR Levee Log, 1990. USACE Sacramento O&M Manual Unit 120, Willow Slough Channel Relocation and Levee Construction, February 1947, Drawing No. 50-4-2281 Sheet 4 (Station 287+19)] FS Date: 5/14/2015 1:44:30 PM

Waterside view- overview

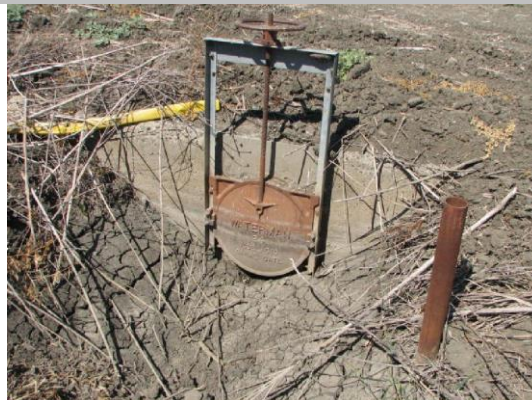
Photo 1 of 3 : UCIP\_FA\_2018\_45305\_22861.jpg

Comment Code					
Inspector Comment					
FS_ID:45305 DS_ID:551 EP_NO: 10325 Repair Type: No Action Needed Crossing Status: Found UCIP Comments: 04/12/2017 WS & LS - submerged in water, inspected by JK, RF. (DWR Sacramento Yard - C. Lund) 09/20/2012 Slide gate on landside of the levee over the field. (DWR UCIP - P. Amatya) FIELD_STRUCT_DESC: 24-inch corrugated metal drainage pipe through the levee, 18 feet below the crown. Flap gate is located on the waterside (WS) end. (24-inch pipe [HLM 5.50] authorized under Automatic Board Order (ABO) issued as Permit No. 10325, 1974 - Ferris). [Additional Reference(s): DWR Levee Log, 1990. USACE Sacramento O&M Manual Unit 120, Willow Slough Channel Relocation and Levee Construction, February 1947, Drawing No. 50-4-2281 Sheet 4 (Station 296+34)] FS Date: 5/14/2015 1:45:21 PM

Landside view- inlet structure.

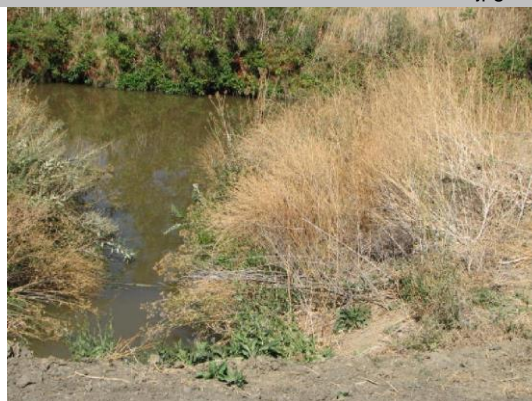
Photo 3 of 3 : UCIP\_FA\_2018\_45305\_22859.jpg

Comment Code						
Inspector Comment						
FS_ID:45305 DS_ID:551 EP_NO: 10325 Repair Type: No Action Needed Crossing Status: Found UCIP Comments: 04/12/2017 WS & LS - submerged in water, inspected by JK, RF. (DWR Sacramento Yard - C. Lund) 09/20/2012 Slide gate on landside of the levee over the field. (DWR UCIP - P. Amatya) FIELD_STRUCT_DESC: 24-inch corrugated metal drainage pipe through the levee, 18 feet below the crown. Flap gate is located on the waterside (WS) end. (24-inch pipe [HLM 5.50] authorized under Automatic Board Order (ABO) issued as Permit No. 10325, 1974 - Ferris). [Additional Reference(s): DWR Levee Log, 1990. USACE Sacramento O&M Manual Unit 120, Willow Slough Channel Relocation and Levee Construction, February 1947, Drawing No. 50-4-2281 Sheet 4 (Station 296+34)] FS Date: 5/14/2015 1:45:21 PM

Waterside view- overview.

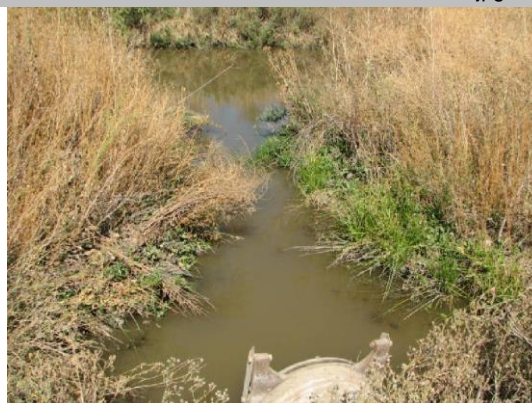
Photo 1 of 3 : UCIP\_FA\_2018\_45306\_22873.jpg

Comment Code					
Inspector Comment					
FS_ID:45306 DS_ID:552 EP_NO: 10338 Repair Type: No Action Needed Crossing Status: Found UCIP Comments: 04/12/2017 WS - submerged in water, inspected by JK, RF. (DWR Sacramento Yard - C. Lund) 09/20/2012 Open inlet over the field. (DWR UCIP - P. Amatya) FIELD_STRUCT_DESC: 36-inch corrugated metal drainage pipe through the levee, 19 feet below the crown. Flap gate is located on the waterside (WS) end. (36-inch pipe [HLM 5.51] authorized under Automatic Board Order (ABO) issued as Permit No. 10325, 1974 - Ferris) [Additional Reference(s): DWR Levee Log, 1990. USACE Sacramento O&M Manual Unit 120, Willow Slough Channel Relocation and Levee Construction, February 1947, Drawing No. 50-4-2281 Sheet 4 (Station 297+26)] FS Date: 5/14/2015 1:45:32 PM

Waterside view- overview.

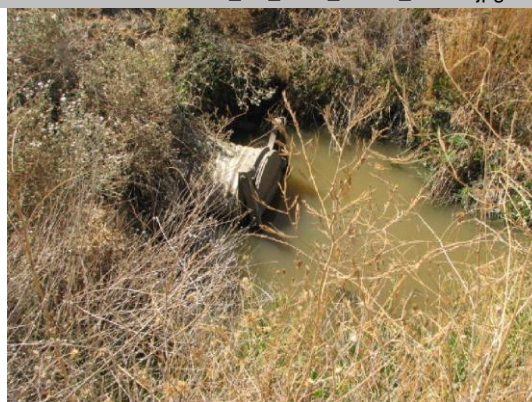
Photo 2 of 3 : UCIP\_FA\_2018\_45306\_22872.jpg

Waterside view- pipe and flap gate.

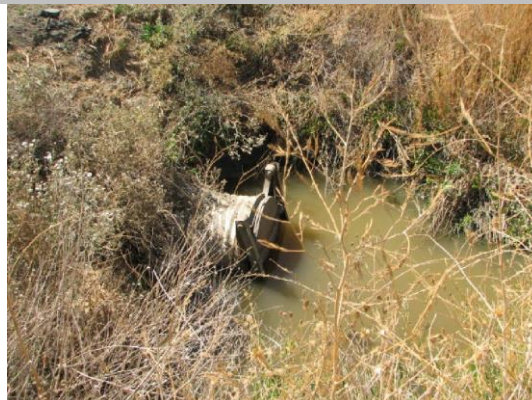
Photo 3 of 3 : UCIP\_FA\_2018\_45306\_22876.jpg

Comment Code						
Inspector Comment						
FS_ID:45306 DS_ID:552 EP_NO: 10338 Repair Type: No Action Needed Crossing Status: Found UCIP Comments: 04/12/2017 WS - submerged in water, inspected by JK, RF. (DWR Sacramento Yard - C. Lund) 09/20/2012 Open inlet over the field. (DWR UCIP - P. Amatya) FIELD_STRUCT_DESC: 36-inch corrugated metal drainage pipe through the levee, 19 feet below the crown. Flap gate is located on the waterside (WS) end. (36-inch pipe [HLM 5.51] authorized under Automatic Board Order (ABO) issued as Permit No. 10325, 1974 - Ferris) [Additional Reference(s): DWR Levee Log, 1990. USACE Sacramento O&M Manual Unit 120, Willow Slough Channel Relocation and Levee Construction, February 1947, Drawing No. 50-4-2281 Sheet 4 (Station 297+26)] FS Date: 5/14/2015 1:45:32 PM

Waterside view- pipe and flap gate.

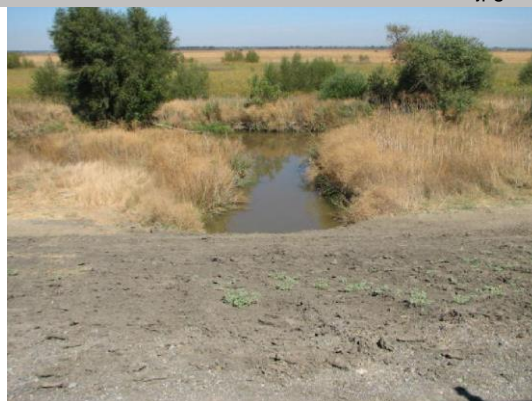
Photo 1 of 3 : UCIP\_FA\_2018\_45307\_22869.jpg

Comment Code					
Inspector Comment					
FS_ID:45307 DS_ID:553 EP_NO: 10325 Repair Type: No Action Needed Crossing Status: Found UCIP Comments: 04/12/2017 WS - submerged in water, inspected by JK, RF. (DWR Sacramento Yard - C. Lund) 09/20/2012 Outlet structure under water in waterside of the levee. No access to the inlet structure. (DWR UCIP - P. Amatya) FIELD_STRUCT_DESC: 24-inch corrugated metal drainage pipe through the levee, 18 feet below the crown. Flap gate is located on the waterside (WS) end. (24-inch pipe [HLM 5.98] authorized under Automatic Board Order (ABO) issued as Permit No. 10325, 1974 - Ferris) [Additional Reference(s): DWR Levee Log, 1990. USACE Sacramento O&M Manual Unit 120, Willow Slough Channel Relocation and Levee Construction, February 1947, Drawing No. 50-4-2281 Sheet 4 (Station 328+51)] FS Date: 5/14/2015 1:45:44 PM

Waterside view- overview

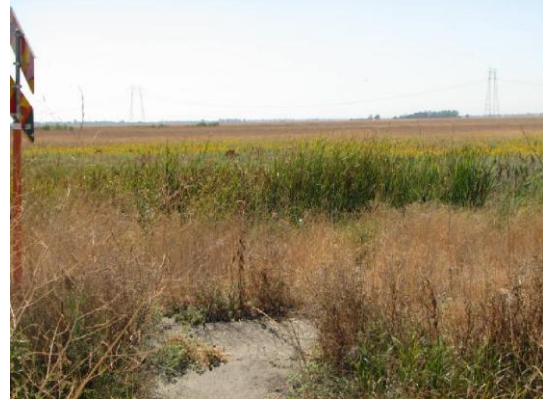
Photo 3 of 3 : UCIP\_FA\_2018\_45307\_22870.jpg

Comment Code						
Inspector Comment						
FS_ID:45307 DS_ID:553 EP_NO: 10325 Repair Type: No Action Needed Crossing Status: Found UCIP Comments: 04/12/2017 WS - submerged in water, inspected by JK, RF. (DWR Sacramento Yard - C. Lund) 09/20/2012 Outlet structure under water in waterside of the levee. No access to the inlet structure. (DWR UCIP - P. Amatya) FIELD_STRUCT_DESC: 24-inch corrugated metal drainage pipe through the levee, 18 feet below the crown. Flap gate is located on the waterside (WS) end. (24-inch pipe [HLM 5.98] authorized under Automatic Board Order (ABO) issued as Permit No. 10325, 1974 - Ferris) [Additional Reference(s): DWR Levee Log, 1990. USACE Sacramento O&M Manual Unit 120, Willow Slough Channel Relocation and Levee Construction, February 1947, Drawing No. 50-4-2281 Sheet 4 (Station 328+51)] FS Date: 5/14/2015 1:45:44 PM

Landside view- overview

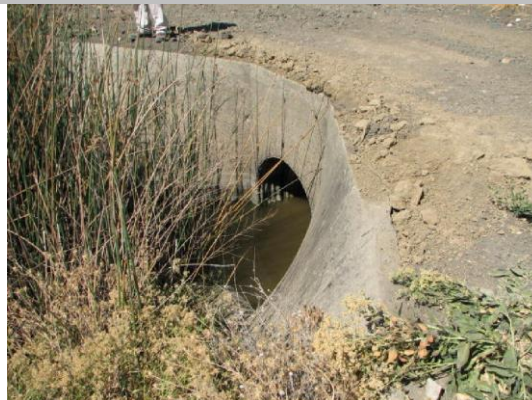
Photo 1 of 2 : UCIP\_FA\_2018\_45309\_22878.jpg

Comment Code					
Inspector Comment					
FS_ID:45309 DS_ID:555 EP_NO: 10338 Repair Type: No Action Needed Crossing Status: Found UCIP Comments: 04/12/2017 WS & LS - submerged in water, inspected by JK, RF. (DWR Sacramento Yard - C. Lund) FIELD_STRUCT_DESC: 42-inch corrugated metal drainage pipe through the levee, 23.5 feet below the crown. Flap gate is located on the waterside (WS) end. Concrete headwall with wing walls is located on the landside (LS). (42-inch pipe [HLM 6.92] authorized under Automatic Board Order (ABO) issued as Permit No. 10338, 1974 - Woodland Farms, Ltd) [Additional Reference(s): DWR Levee Log, 1990. USACE Sacramento O&M Manual Unit 120, Willow Slough Channel Relocation and Levee Construction, February 1947, Drawing No. 50-4-2281 Sheet 5 (Station 374+00)] FS Date: 5/14/2015 1:46:34 PM

Landside view- Wing wall and pipe
